CENTROCOT
Innovation experience

Object	Physical durability
Rev.	0.4 del 16/10/2024
Ref RdP	24RA10311-14-28-29

INVESTIGATION
IN PHYSICAL DURABILITY
OF KNITTED FABRIC AND FINISHED GARMENTS

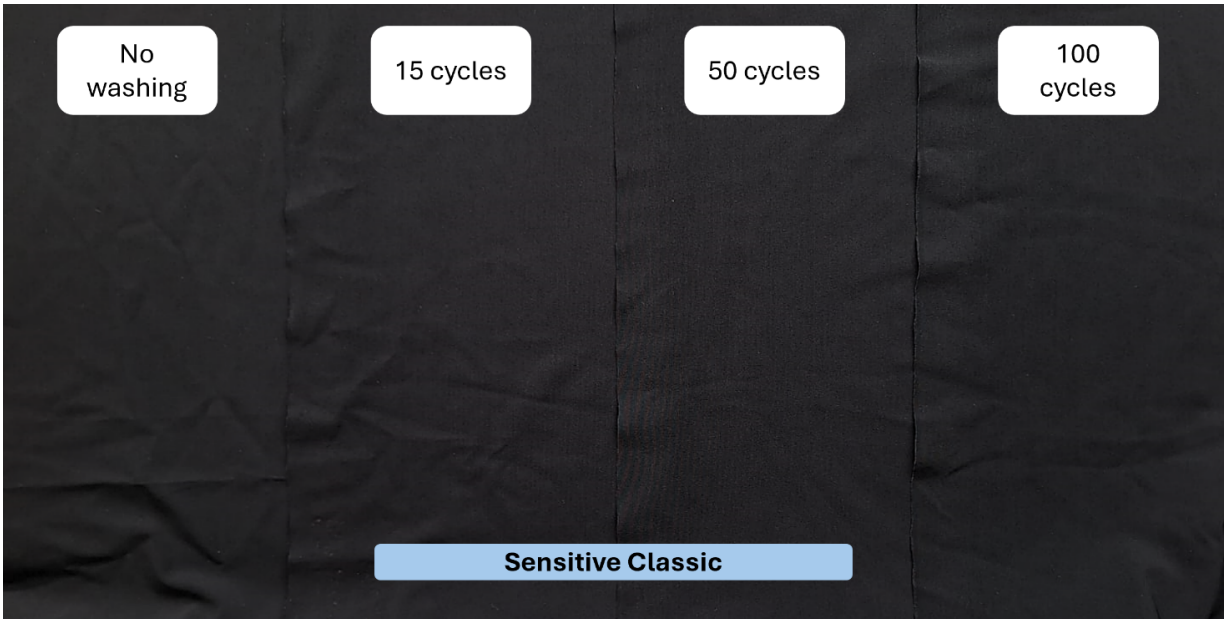
No holes were detected in knitted fabric after laundering cycles. No significant change was observed after 100 laundering cycles in Sensitive Classic fabric.

Figure 1. Appearance of Sensitive Classic fabric samples before and after 15, 50, 100 cycles of washing and drying.

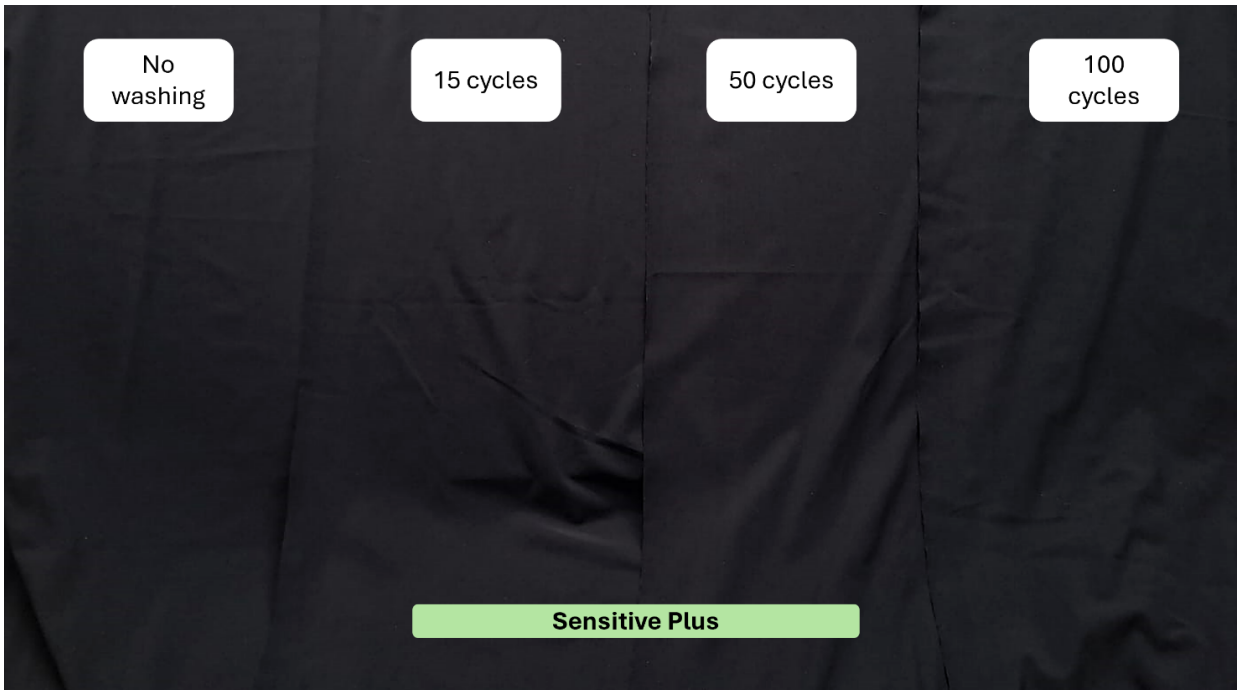
No holes were detected in knitted fabric after laundering cycles. No significant change was observed after laundering cycles in Sensitive Plus Fabric, as reported in Figure 2.

Figure 2. Appearance of Sensitive Plus fabric samples before and after 15, 50, 100 cycles of washing and drying.

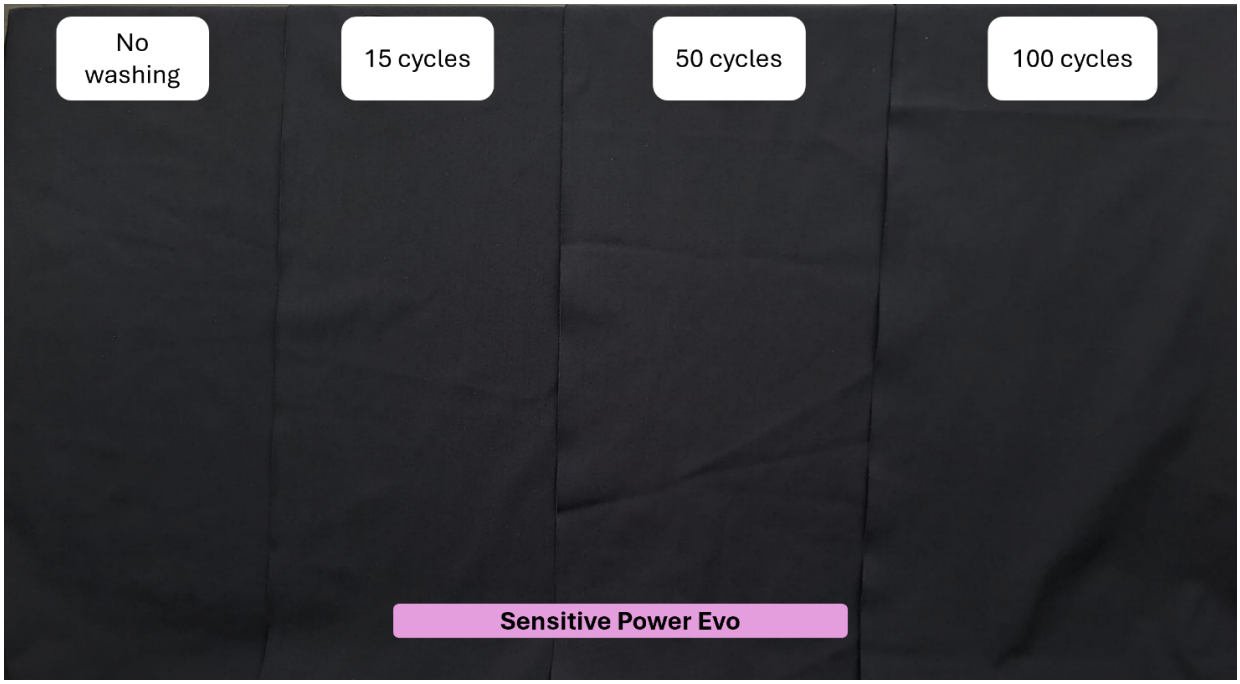
No holes were detected in knitted fabric after laundering cycles. No significant change was observed after laundering cycles in Sensitive Power Evo sample, as visible in Figure 3.

Figure 3. Appearance of Sensitive Power Evo fabric samples before and after 15, 50, 100 cycles of washing and drying.

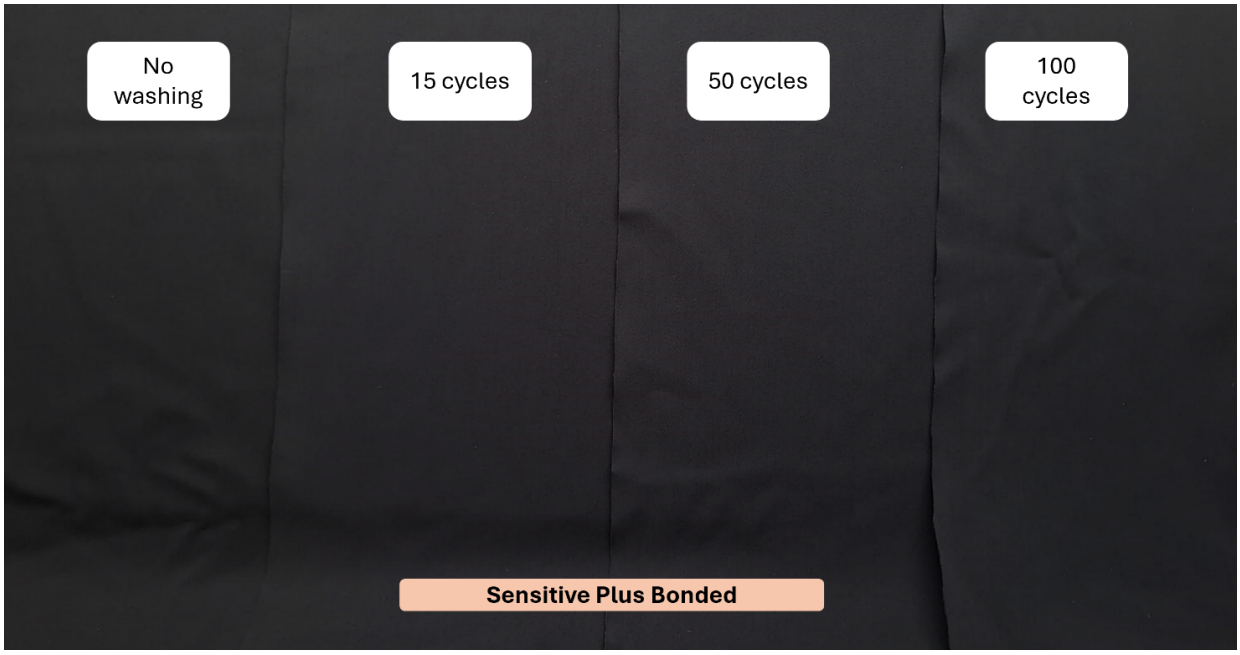
No holes were detected in knitted fabric after laundering cycles. No significant change was observed after laundering cycles in Sensitive Plus Bonded, as visible in Figure 4. Appearance of Sensitive Plus Bonded fabric samples before and after 15, 50, 100 cycles of washing and drying.

Figure 4. Appearance of Sensitive Plus Bonded fabric samples before and after 15, 50, 100 cycles of washing and drying.

As reported in Table 32 none of the parameters indicate surface abrasion for Sensitive Plus Bonded fabric with the Martindale test. Nonetheless, after 50 cycles, the yarn was broken, showing a hole in the knit. After 100 cycles of laundering, the fabric shows abrasion resistance highly above the threshold of >25000 cycles and >20000 cycles.

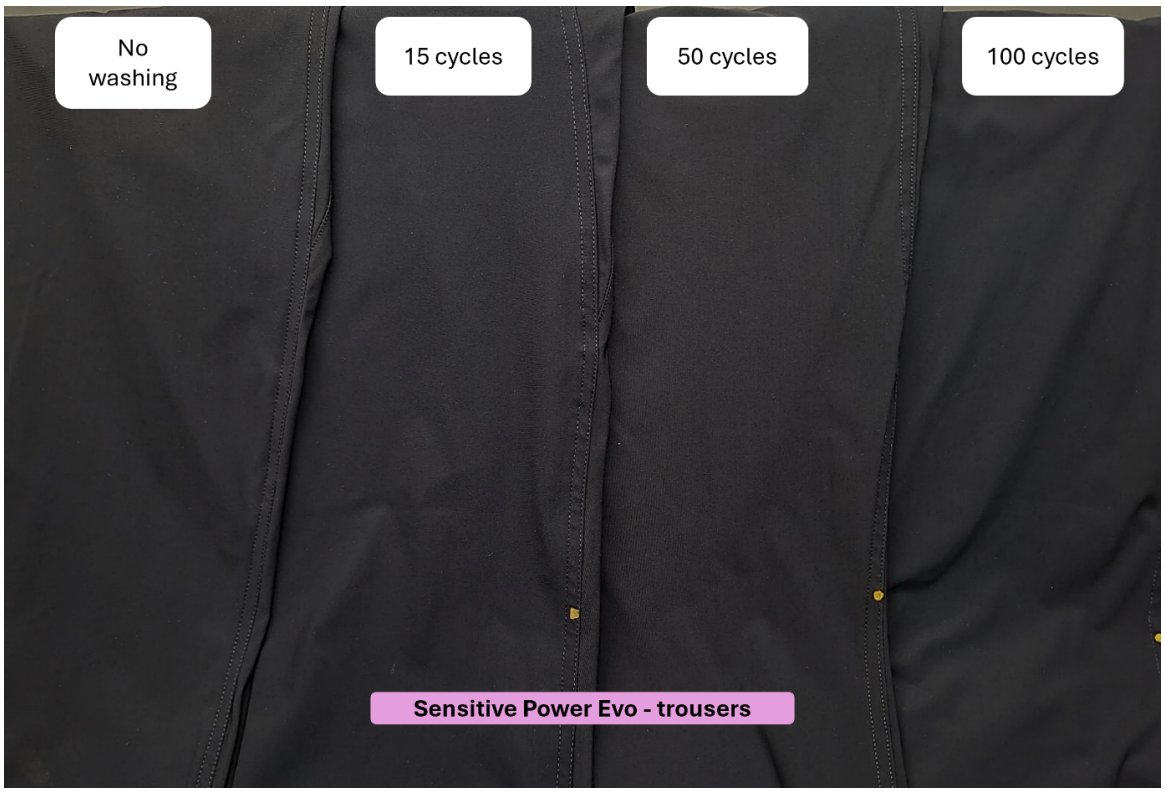
After washing treatments, no alteration in the surface/structural appearance of the garment was observed after laundering cycles in Sensitive Power Evo trousers, as clearly visible in Figure 5. Appearance of Sensitive Power Evo trousers before and after 15, 50, 100 cycles of washing and drying.

Only moderate button degradation is observed after 15 cycles and distinct button degradation after 50 and 100 cycles, but clearly this is not dependent on fabric.

Figure 5. Appearance of Sensitive Power Evo trousers before and after 15, 50, 100 cycles of washing and drying.

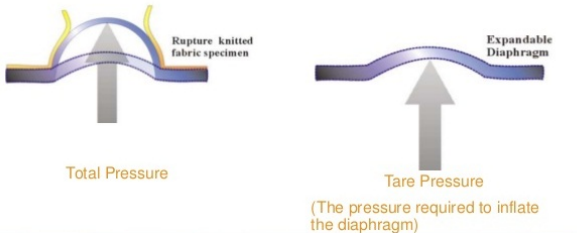
Bursting strength points are referred to the maximum force (pressure) measured during the process of pressing the fabric in the direction of the spherical top bar perpendicular to the plane of the specimen until it is broken.

It is a significant mechanical index of the fabric, directly reflecting the durability index of knitted fabric when the specimen is deformed and ruptured by the external pressure from the top.

In the bursting strength test, the larger the test area, the larger the test area of the specimen subjected to stress and the more yarns will be stressed on the fabric. Thus, with the increase in the test area, the bursting strength should be reduced.

In the present study, two different test areas were tested, namely 7.3 cm^3 and 10 cm^2, to see difference and set test parameters.

It was observed that for 10 cm^2 test area, the values of bursting strength for samples after different cycles of washing were almost the same but the samples did not burst, thus leading to incomplete analysis.
